HITLER'S TANKS

GERMAN PANZERS OF WORLD WAR II

EDITED BY
CHRIS McNAB

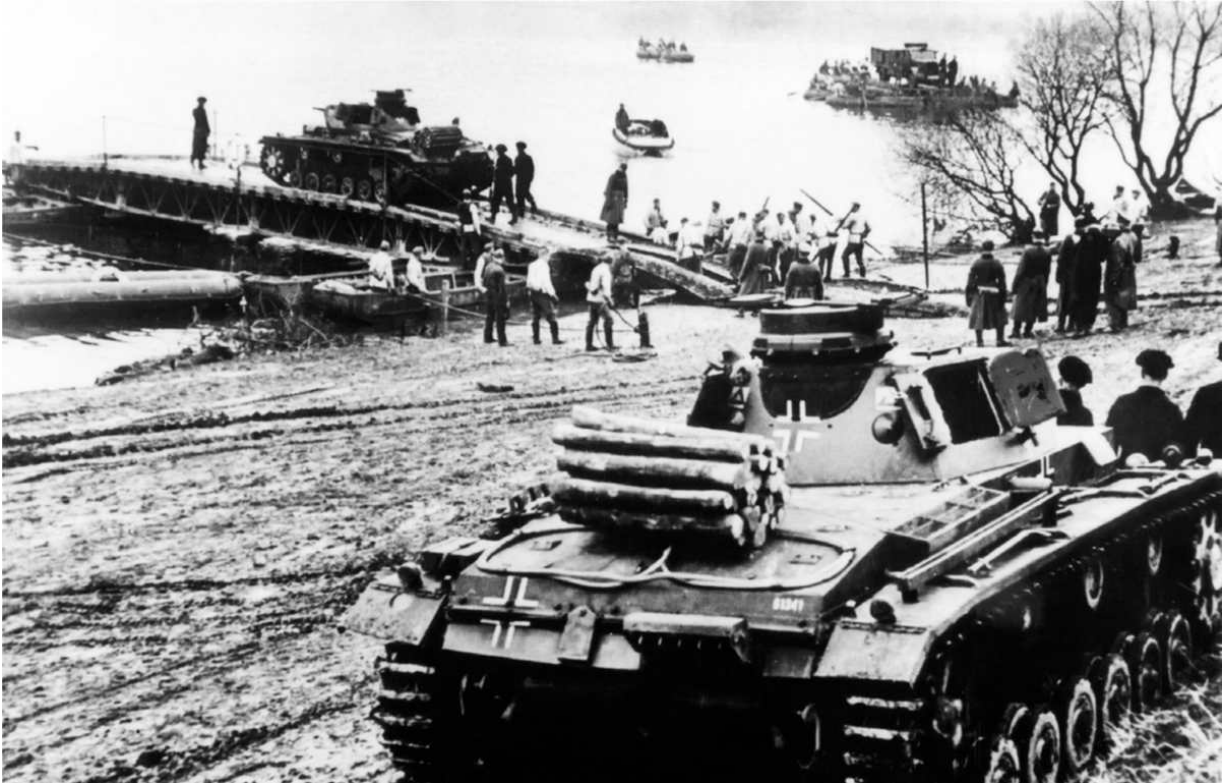
PzKpfw IIIs are driven onto ferries for a river crossing in France, 1940. Note the roll of logs on the engine cover: these were useful for gapping ditches or helping the vehicle get free of boggy ground. (AirSeaLand/Cody)

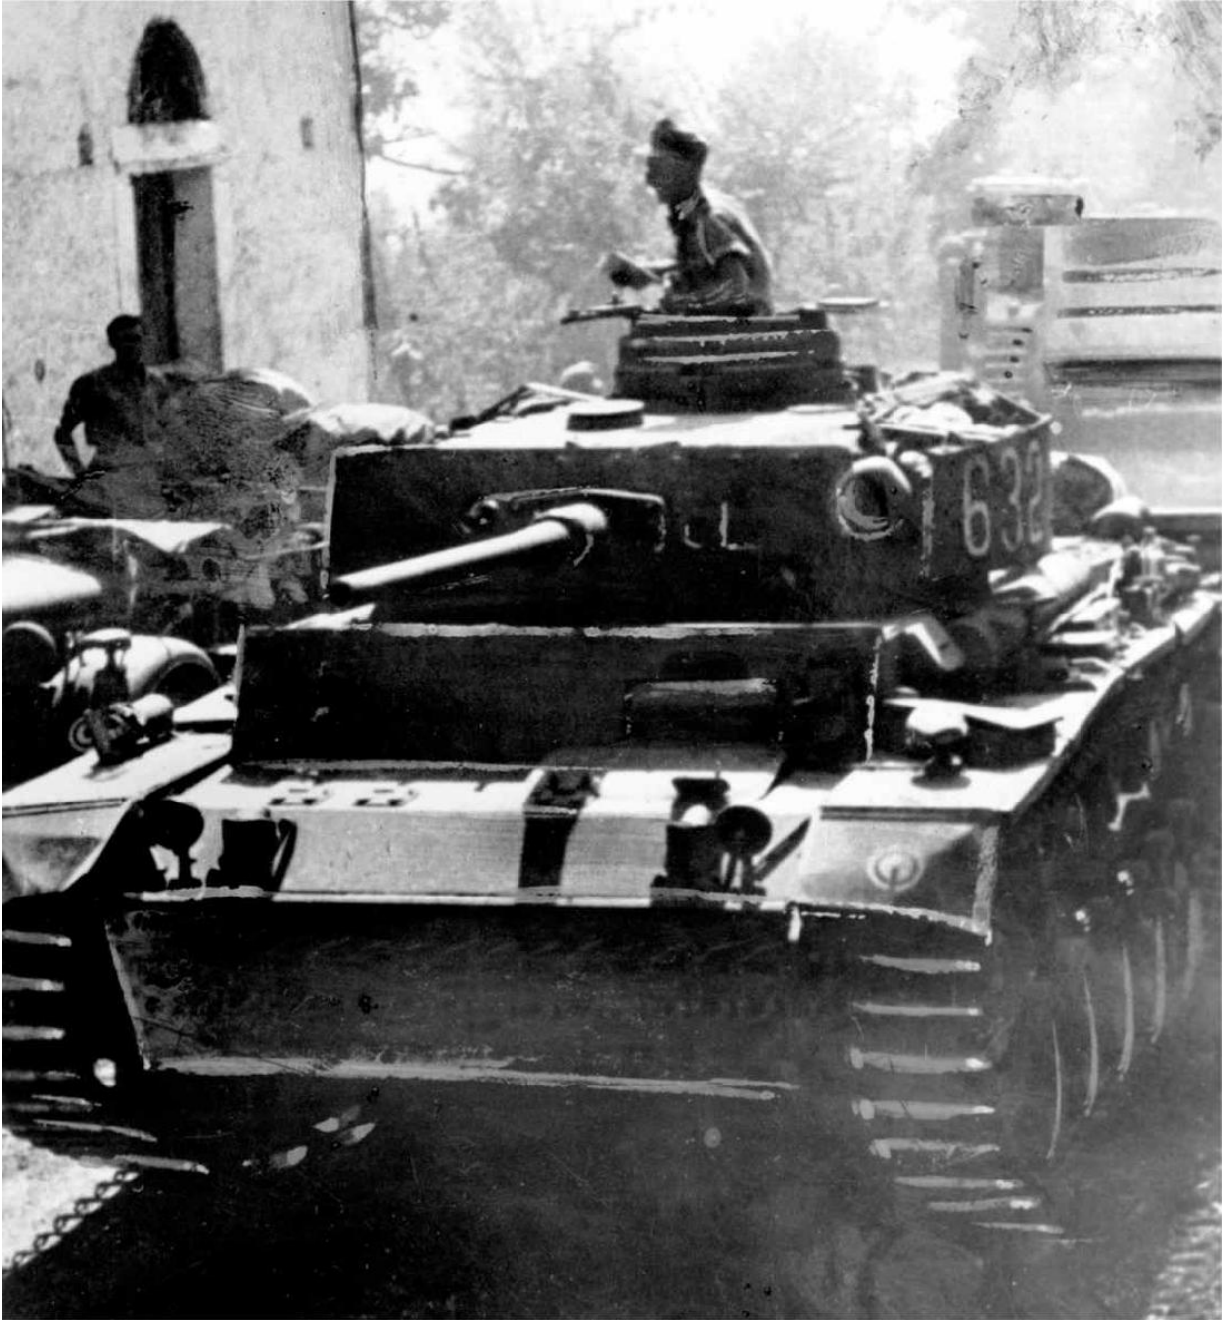
This PzKpfw III is fitted with the longer 5cm KwK 39 L/60. The gun was an improvement over the the 5cm KwK 38 L/42, but it still struggled to penetrate the armour of heavier Allied tanks. (AirSeaLand/Cody)

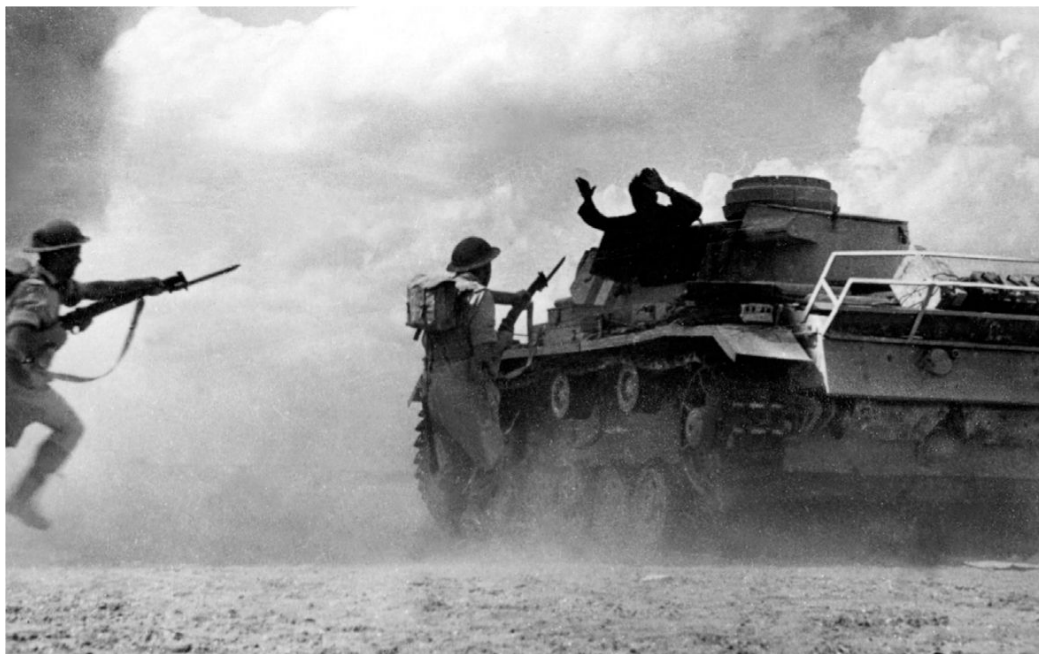
British troops advance to capture the crew of a PzKpfw III in North Africa. Note the frame fitted at the back to carry extra fuel jerry cans and other supplies. (AirSeaLand/Cody)

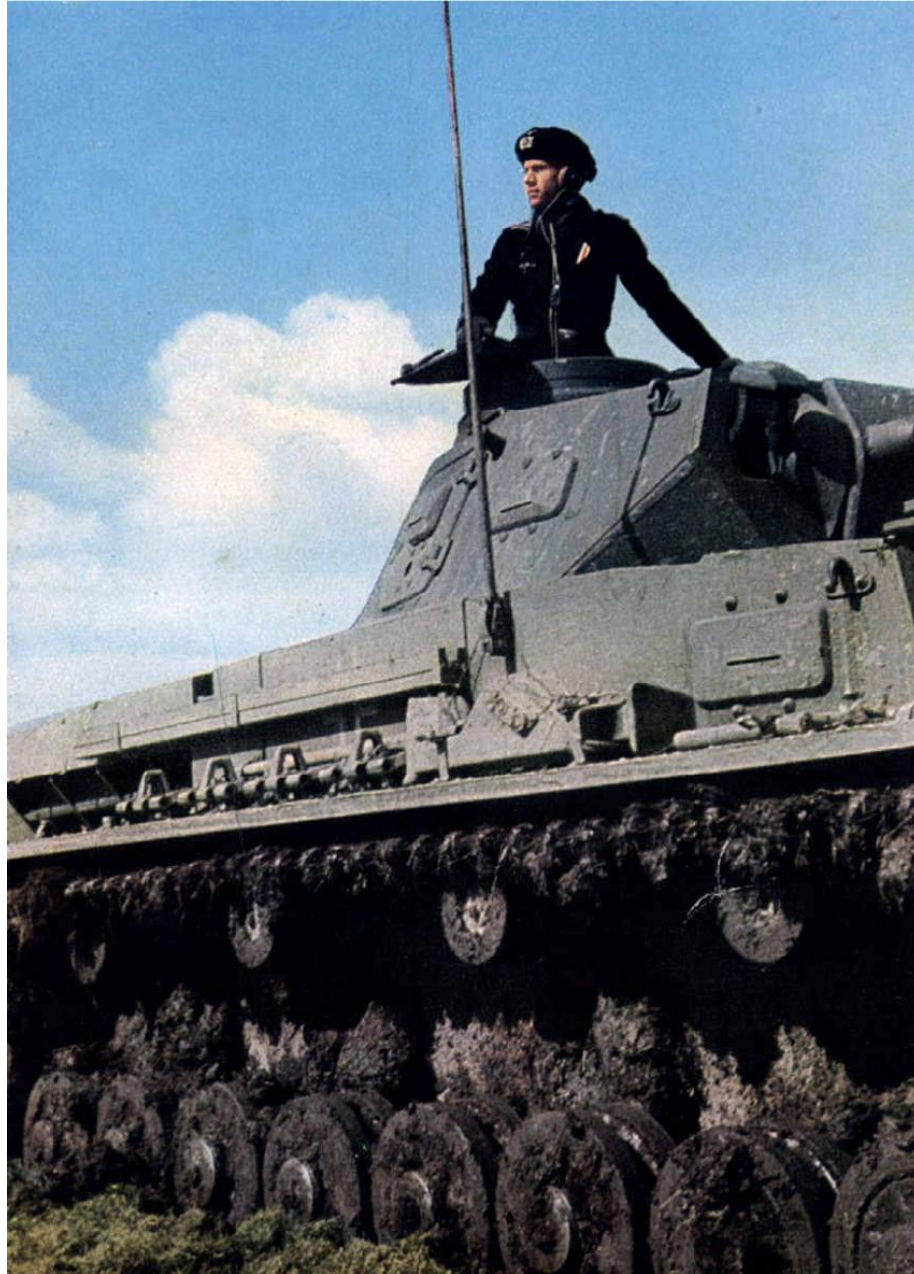
The commander of a PzKpfw III Ausf D conducts observation from his turret during manoeuvres. Frontal armour upgrades were implemented on the Ausf D and later models.
(AirSeaLand/Cody)

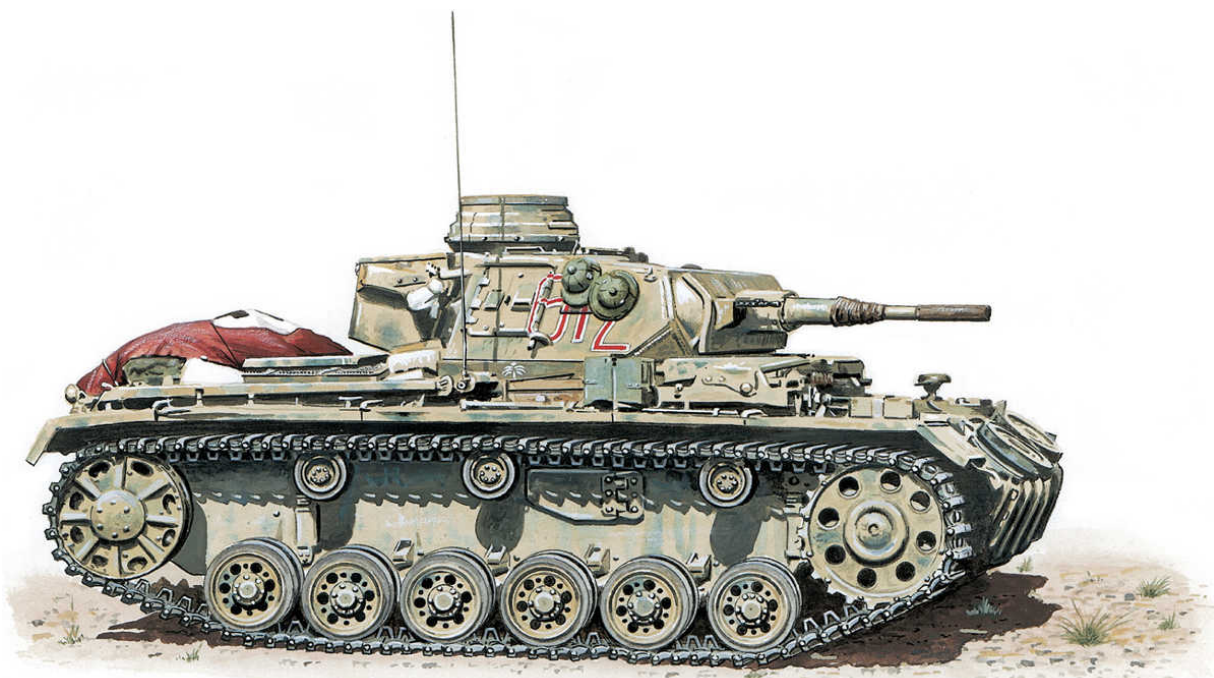
1) PzKpfw III Ausf G, DAK; Libya, 1941. There is a definite 'early days' look about this Ausf G; the original Panzer grey is starting to show through the hastily applied sand-yellow 'slap'.

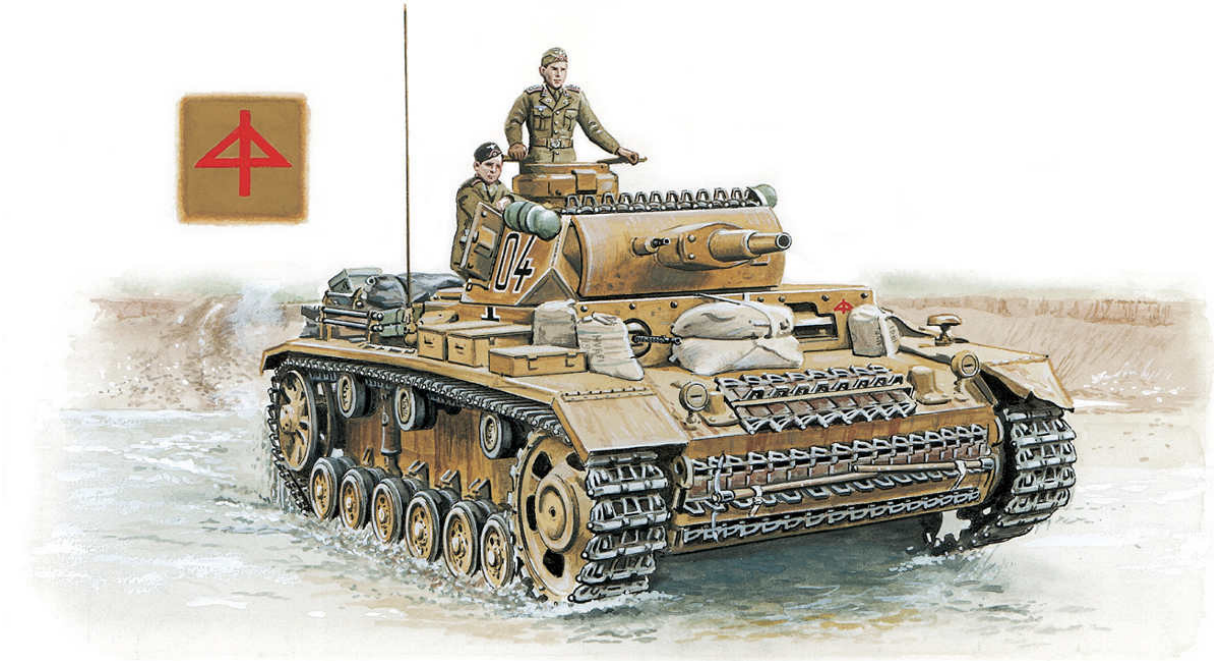
3) PzKpfw III Ausf N, 15. Panzer-Division; Tunisia, 1942–43. The track links draped over the turret roof of this Ausf N reflect the growing Allied air superiority of this period. (David E. Smith © Osprey Publishing)

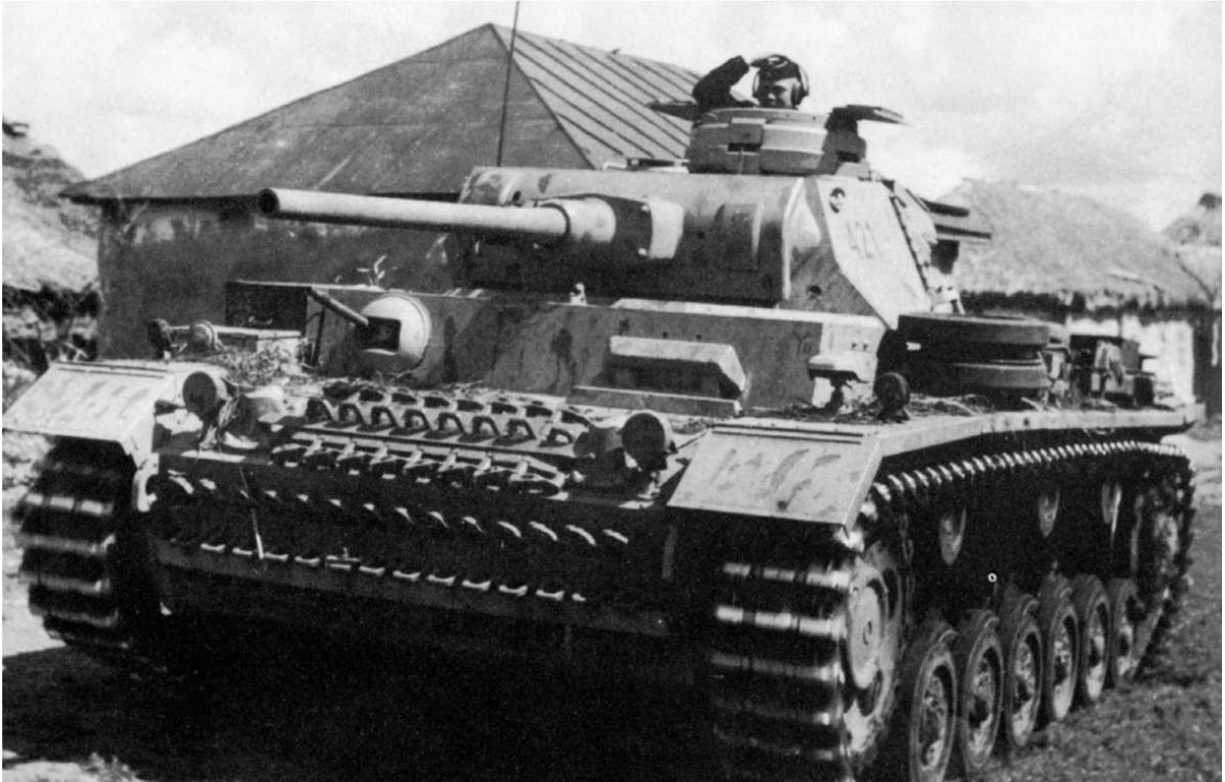
A PzKpfw III Ausf J, which compared to previous models had upgraded armour (50mm front and rear) and better driving controls. (AirSeaLand/Cody)

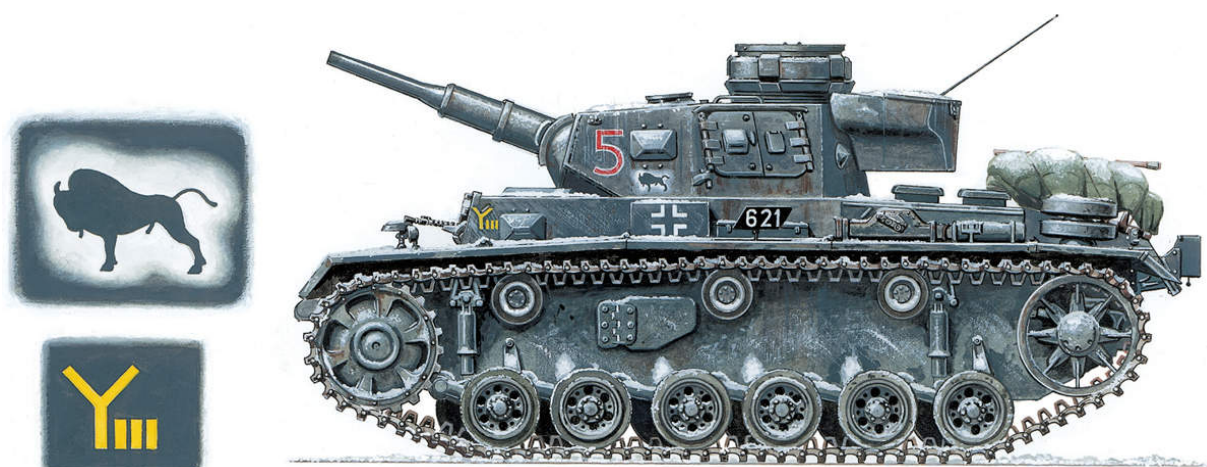
1) PzKpfw III Ausf H, 10. Panzer-Division; Russia, 1941–42. The national cross, in white outline, is painted on a supplementary bin which has been welded to the track-guard.

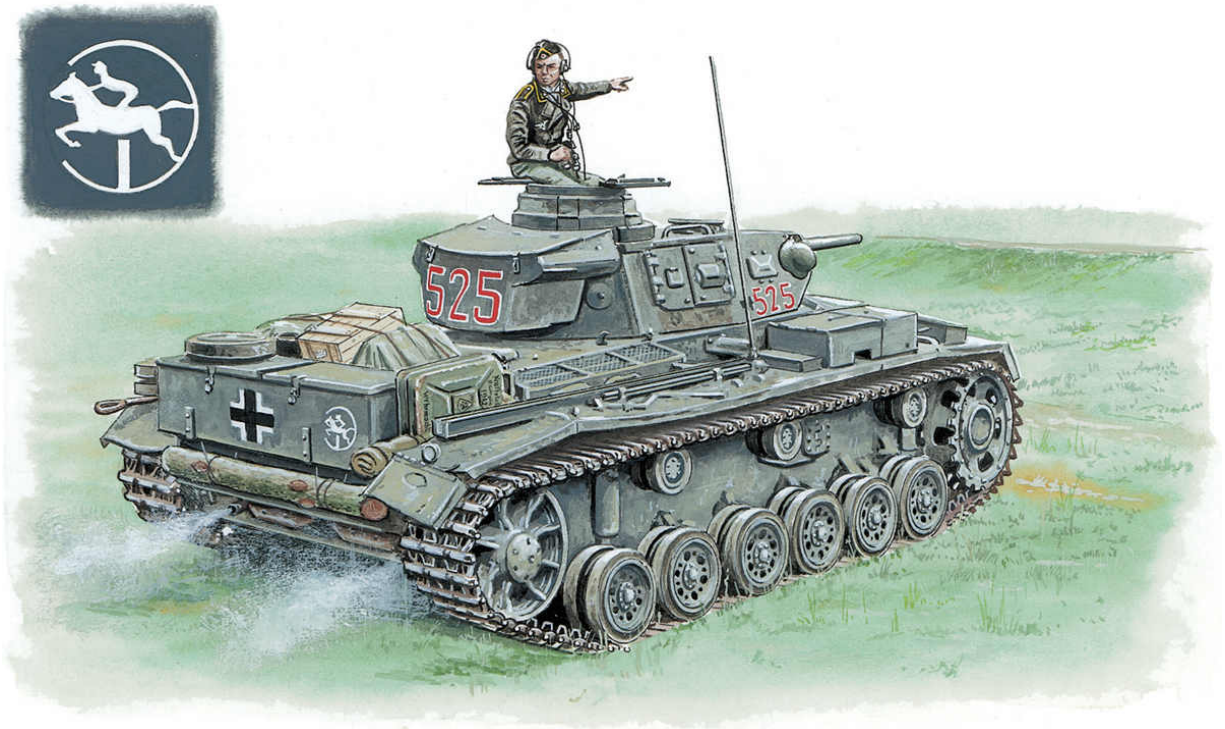
2) Pzkw III Ausf J, 24. Panzer-Division; Russia, 1942. In common with many tanks of this division photographed in Russia, this L/60 Ausf J has a large stowage bin fixed across the rear of the engine deck, and on this can be seen the black and white national cross and the division's distinctive sign. (David E. Smith © Osprey Publishing)

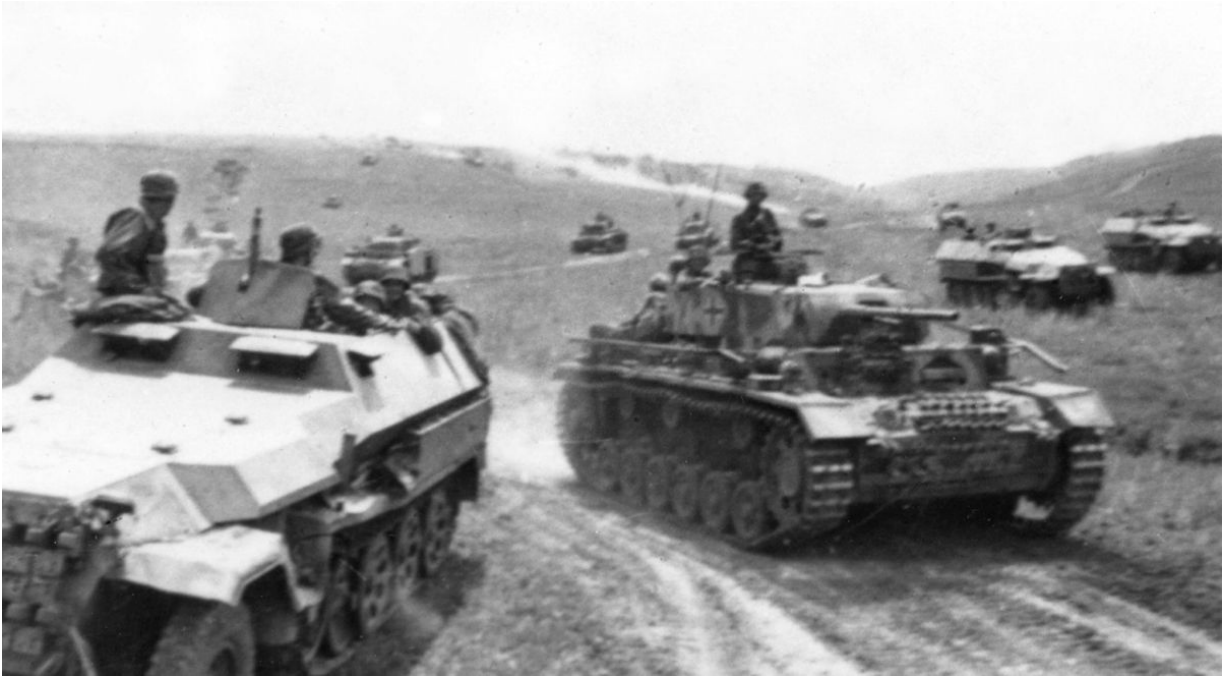
An SdKfz 251 half-track and a PzKpfw III Ausf L lead a formation of vehicles on the Eastern Front. The Ausf L, armed with a 5cm gun, was the tenth PzKpfw III model produced. Production began in July 1942. It was almost identical to the much more numerous Ausf J.
(AirSeaLand/Cody)

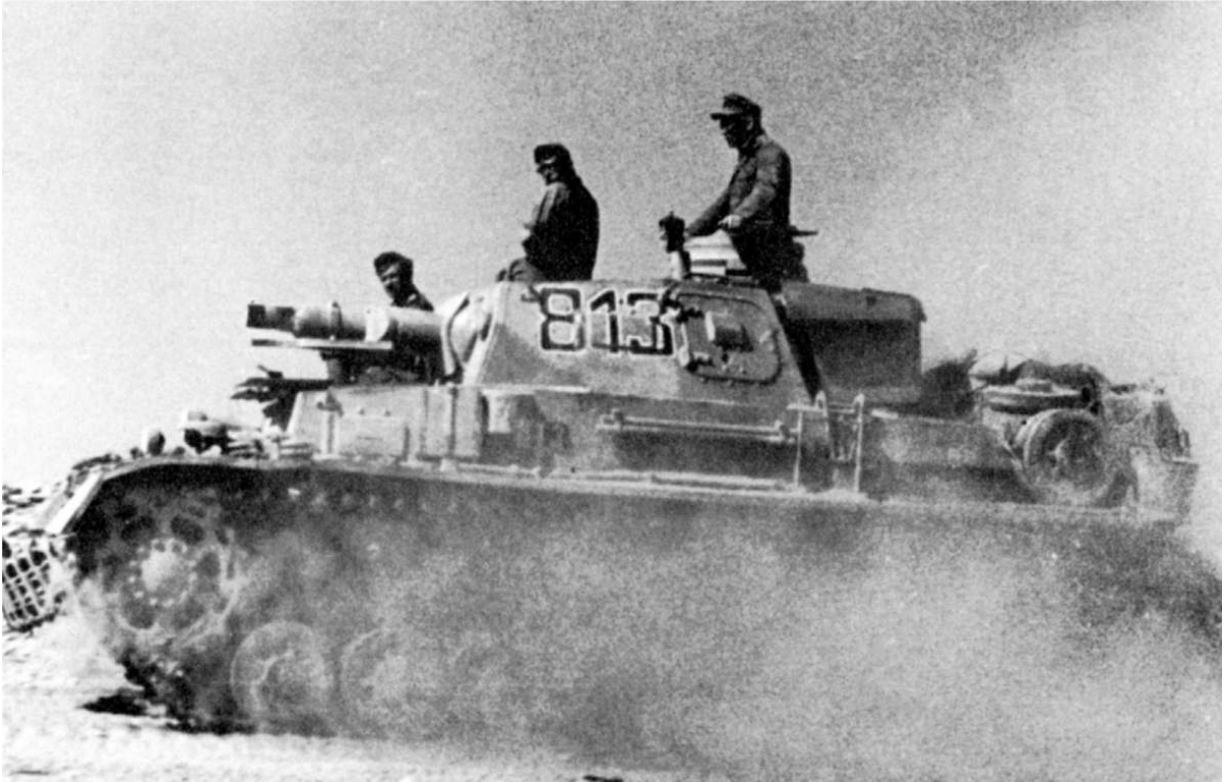
The Ausf D variant, as seen here, had an added shield for the gun mantlet and returned to the use of a hull machine gun, which had been deleted in the Ausf B and C.
(AirSeaLand/Cody)

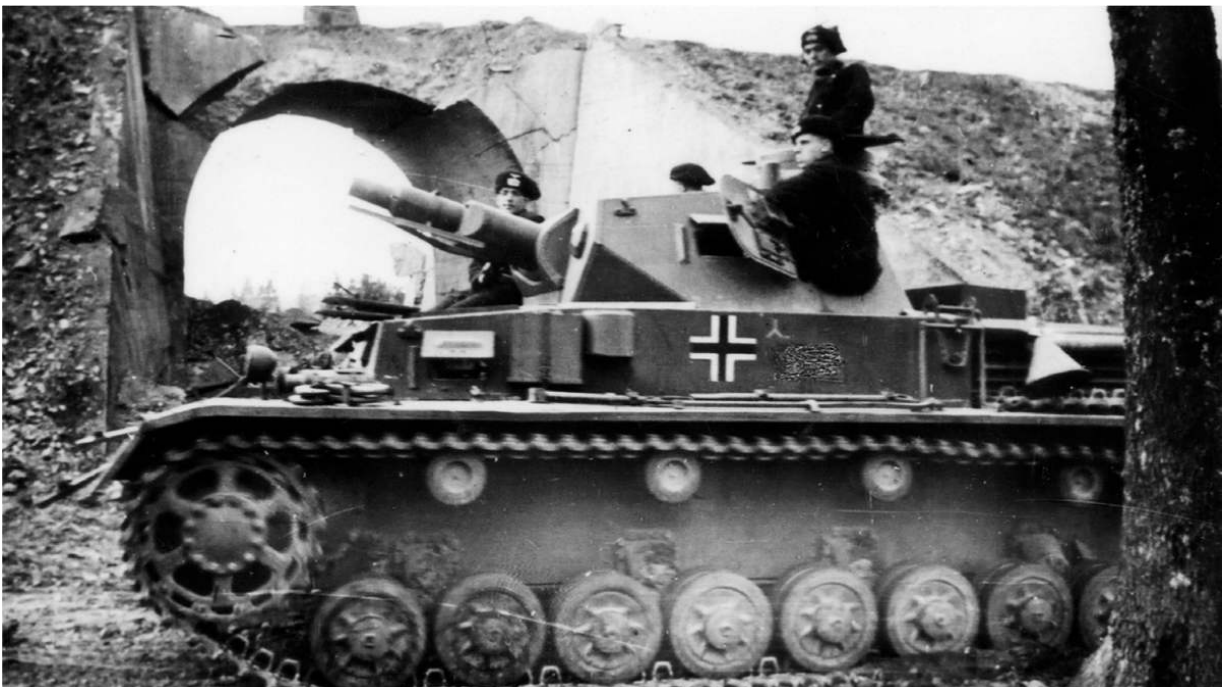
A PzKpfw IV B or C. The main difference between the two was that the Ausf C had thicker turret armour, measuring 30mm depth. (AirSeaLand/Cody)

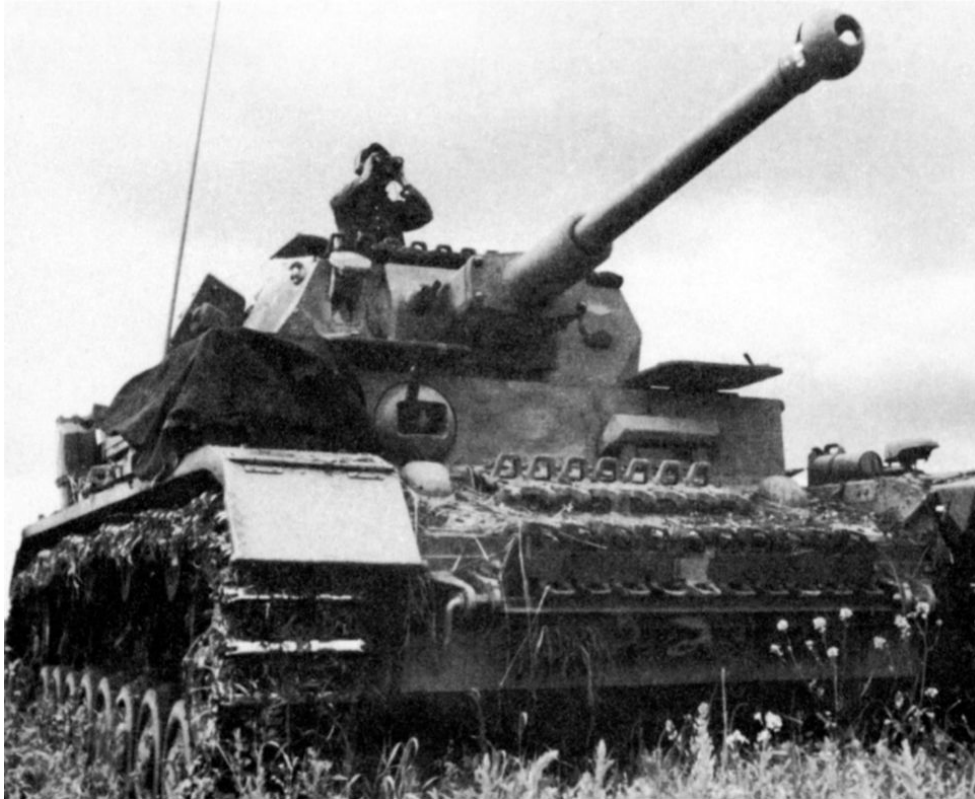
A PzKpfw IV Ausf F2 serving with the 9. Panzer-Division. The full title of the vehicles was the PzKpfw IV (7.5cm KwK 40) (SdKfz 161), 7./B.W., Ausf F2. (AirSeaLand/Cody)

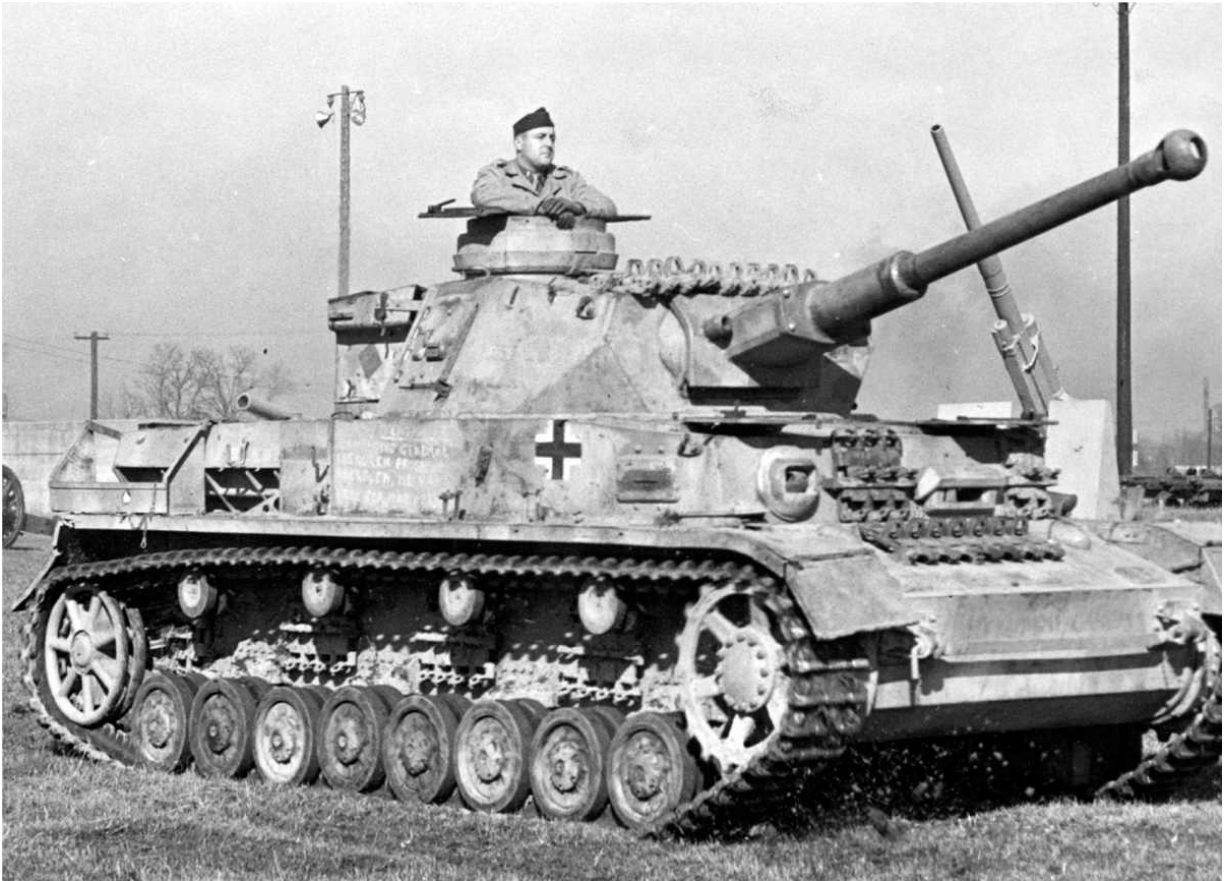
A captured PzKpfw IV Ausf G, featuring the earlier ball-shaped muzzle brake, which was eventually replaced by the squarer multi-baffle design. (AirSeaLand/Cody)

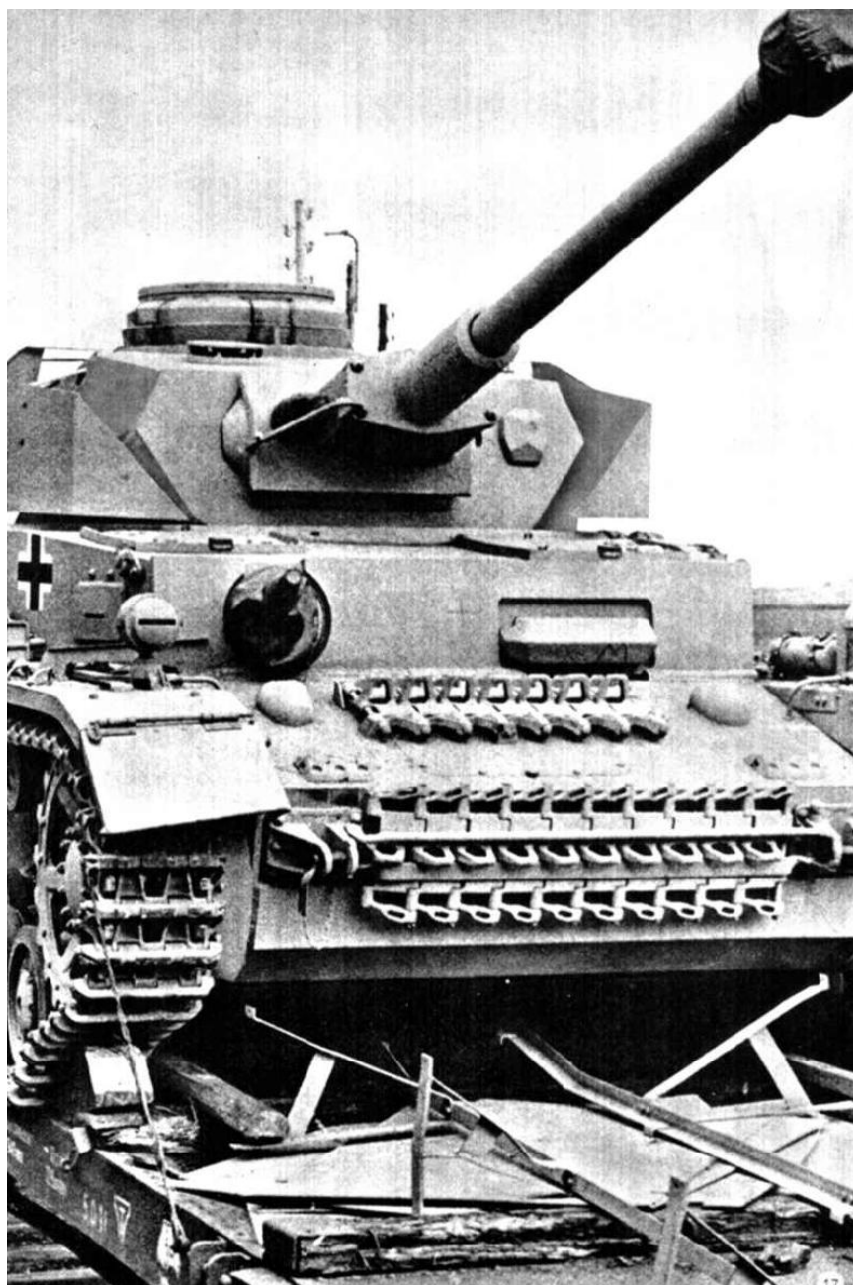
A PzKpfw IV embarked for transportation aboard a train. A German combat report from North Africa noted regarding the tank: 'Because of its distinctive form, it drew concentrated fire down on itself from aircraft, artillery and anti-tank guns.' (AirSeaLand/Cody)

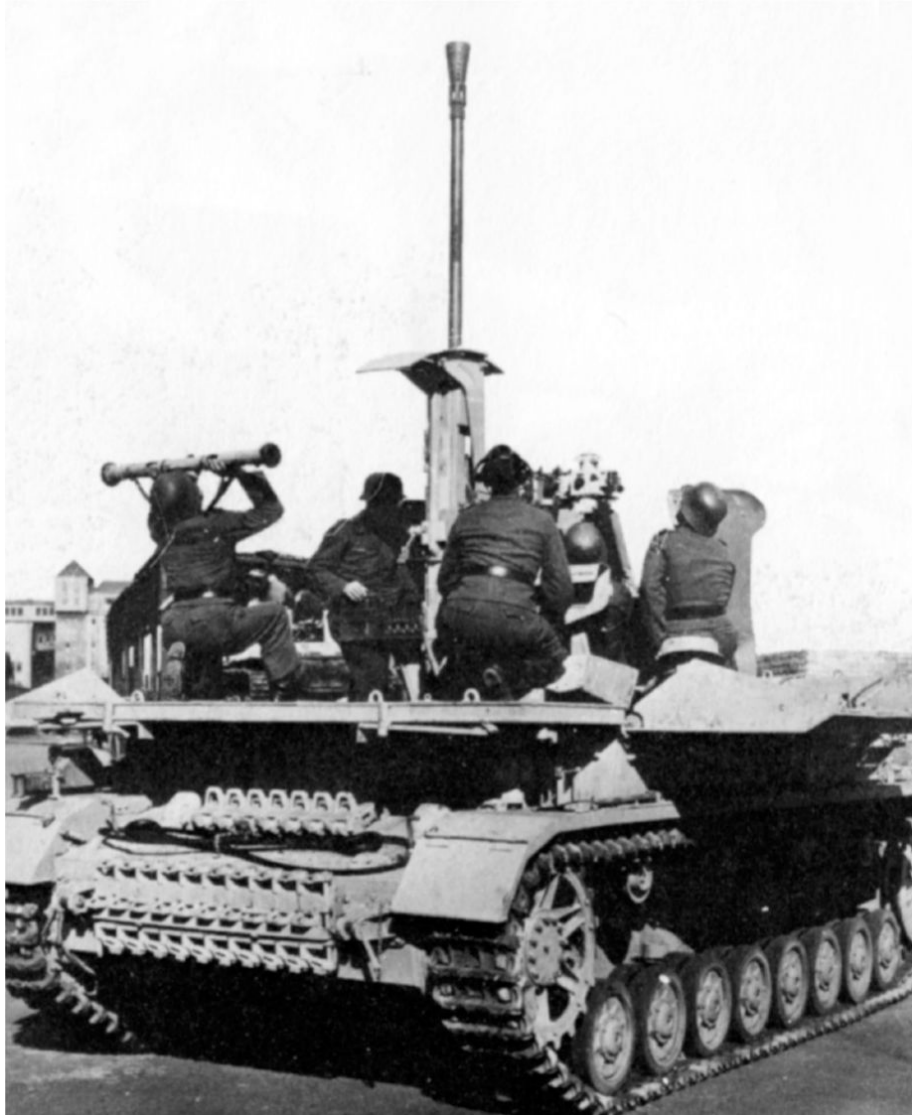
The 3.7cm Flak auf Fahrgestell Panzerkampfwagen IV (sf) (SdKfz 161/3) Möbelwagen (Moving Van) mounted a single 3.7cm Flak 43 L/89. Here note the crewmember on the right using an EM 34 coincidence rangefinder. (AirSeaLand/Cody)

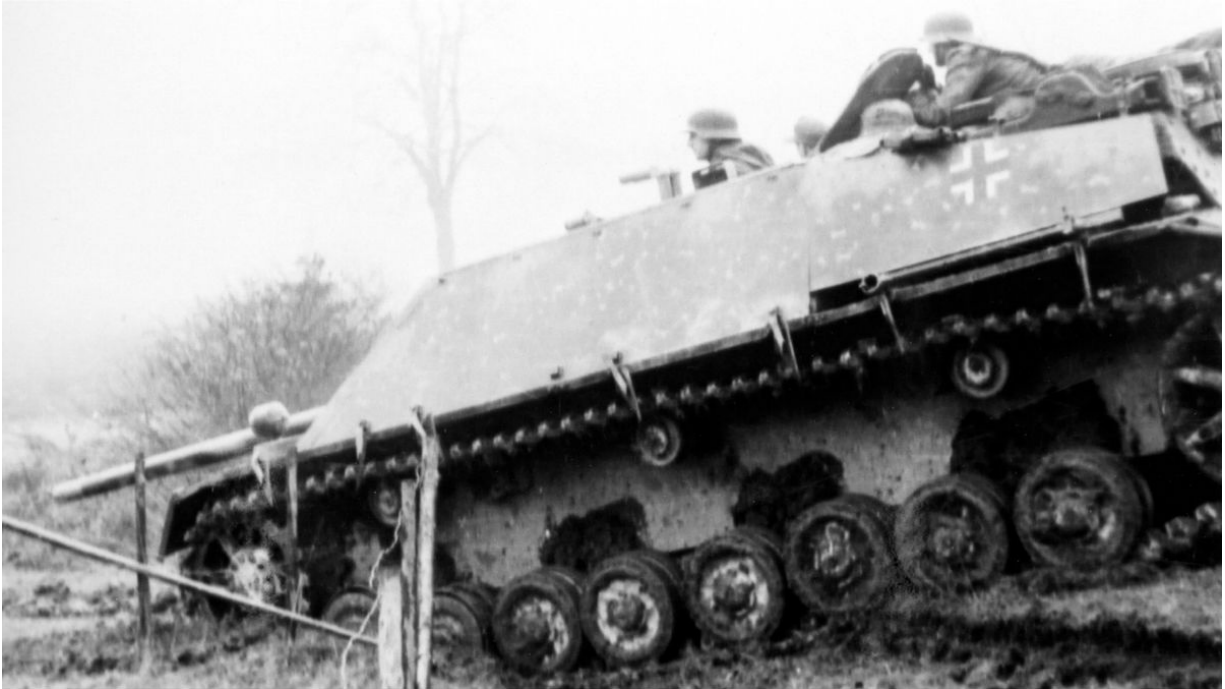
The Jagdpanzer IV (SdKfz 162) used a modified Panzer IV Ausf H chassis, with 80mm-thick sloped armour. With its long 7.5cm PaK 42 L/70 gun, the vehicle was very nose-heavy.
(AirSeaLand/Cody)

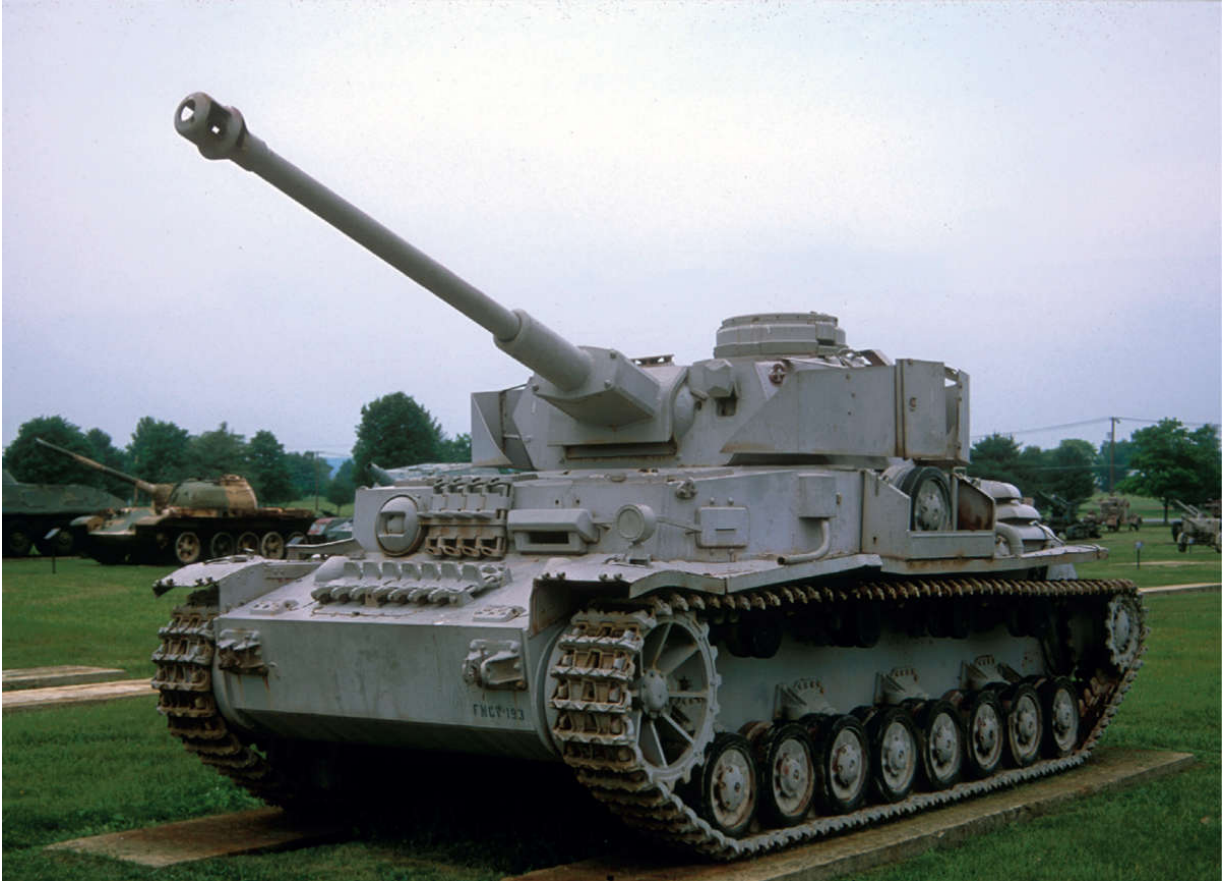
A PzKpfw IV Ausf G, preserved at the Aberdeen Proving Ground in Maryland, United States. In June 1942 an order was made that all PzKpfw IV with the KwK 40 gun were to be referred to as Ausf G. (AirSeaLand/Cody)

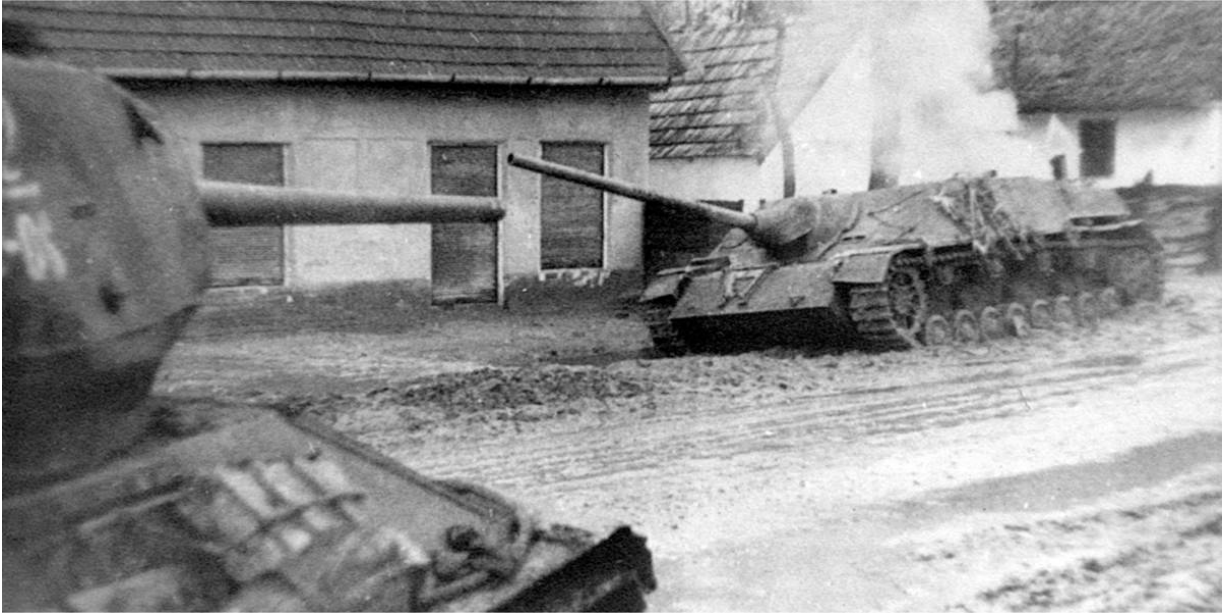
The Jagdpanzer IV – here we see one being destroyed by a Red Army T-34 – was another of the PzKpfw IV derivatives, being essentially a modified Panzer IV Ausf H chassis with sloped 80mm armour plate on the front and fitted with either the 7.5cm PaK 39 L/48 or, later, the 7.5cm PaK 42 L/70. Note the absence of muzzle brake; crews often removed these owing to the heavy kick-up of dust produced by the muzzle brake gun flash. (AirSeaLand/Cody)

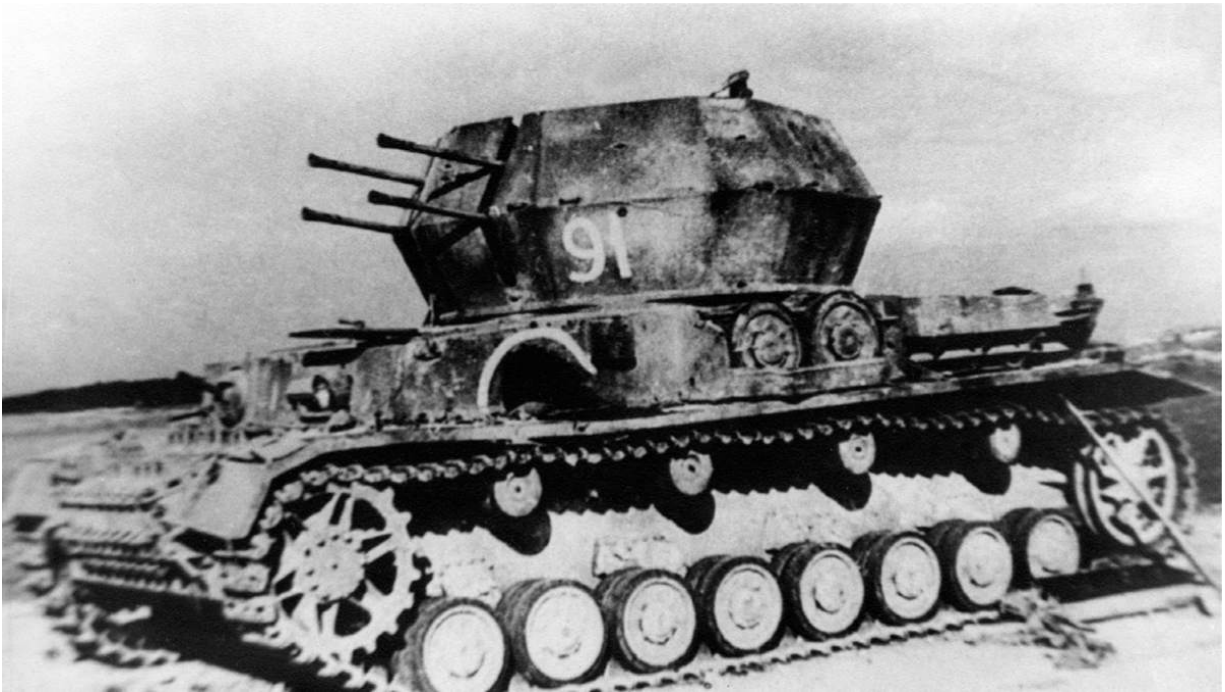
The Flakpanzer IV Wirbelwind (Whirlwind) took the chassis and hull of a PzKpfw IV and topped it with an anti-aircraft turret mounting four 2cm Flak cannon. The maximum practical rate of fire was 800rpm, although standard operating realities usually dropped the figure to around 400rpm. (AirSeaLand/Cody)

A much improved Flakpanzer, the Wirbelwind (Whirlwind), appeared in December 1943, consisting of a 2cm quadruple mounting in an open-topped fully rotating turret with 16mm armour. This was joined in March 1944 by the Ostwind (East Wind), which was almost identical in layout but had 25mm armour and carried a single 3.7cm cannon. Both Wirbelwind and Ostwind

used the Ausf J chassis, and production figures for each model were respectively 140 and 40. The maximum rate of fire of the quadruple 2cm system was 1,800 rounds per minute, but a lower rate was generally set; the 3.7cm's maximum output was 160 rounds per minute.

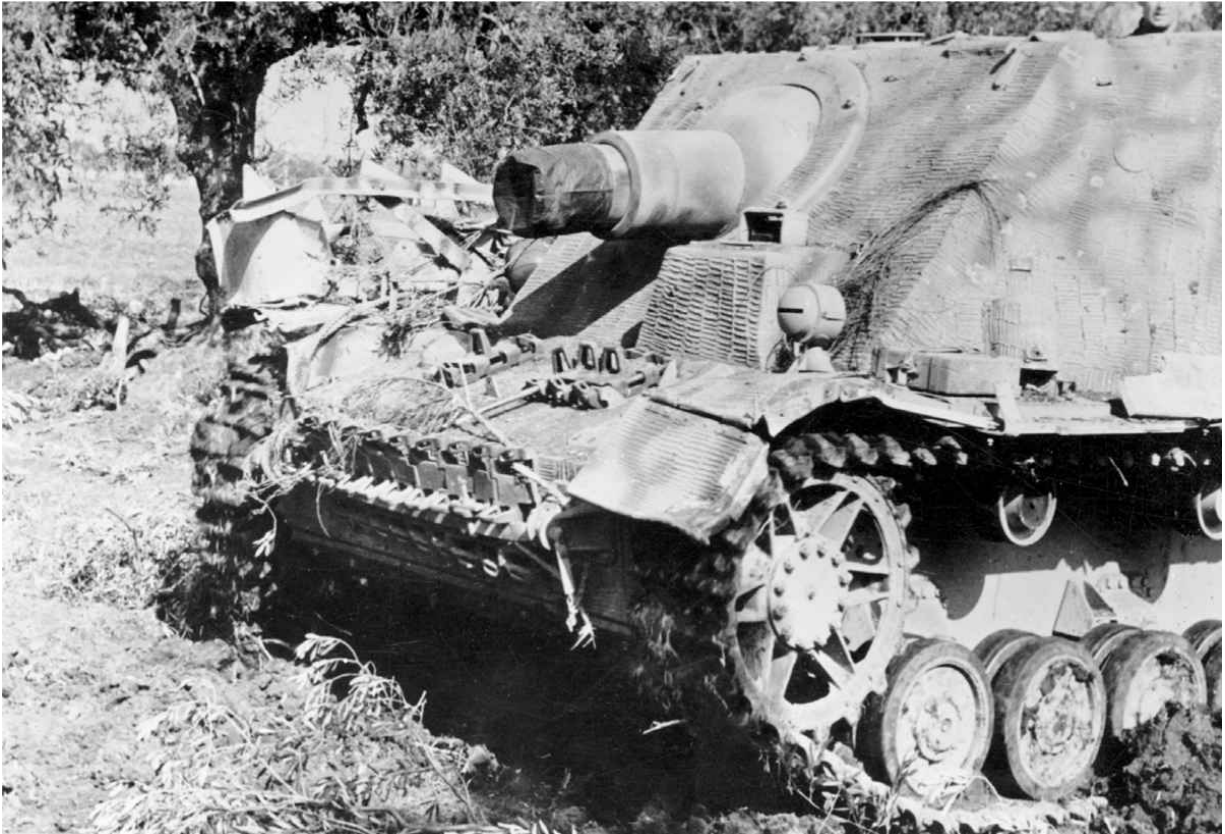
The Sturmpanzer IV Brummbär mounted the wall-smashing 15cm L/12 howitzer, and was principally deployed as a heavy assault gun, breaching obstacles and defences in support of infantry assaults. (AirSeaLand/Cody)

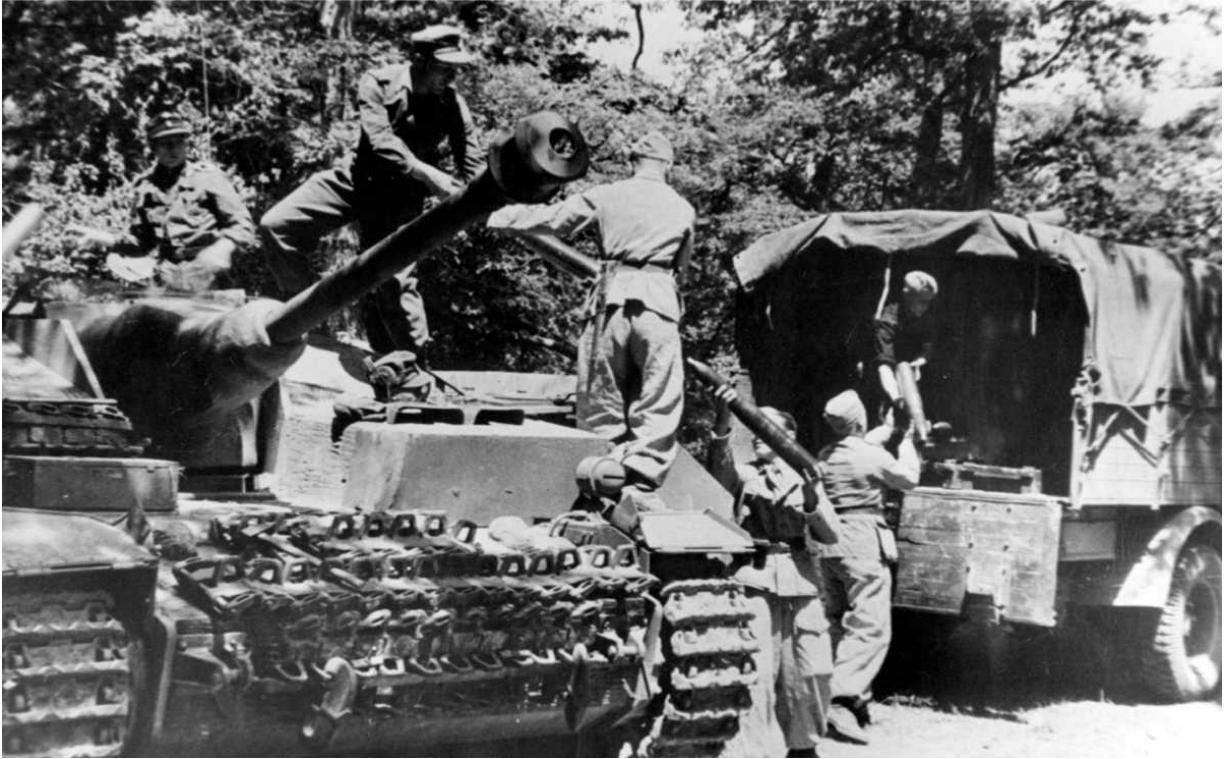
A StuG crew carefully take aboard 7.5cm shells for their KwK 40/StuK 40 anti-tank gun, one of the most effective German anti-tank weapons. Total shell capacity for the StuG IV was 63 rounds. (AirSeaLand/Cody)

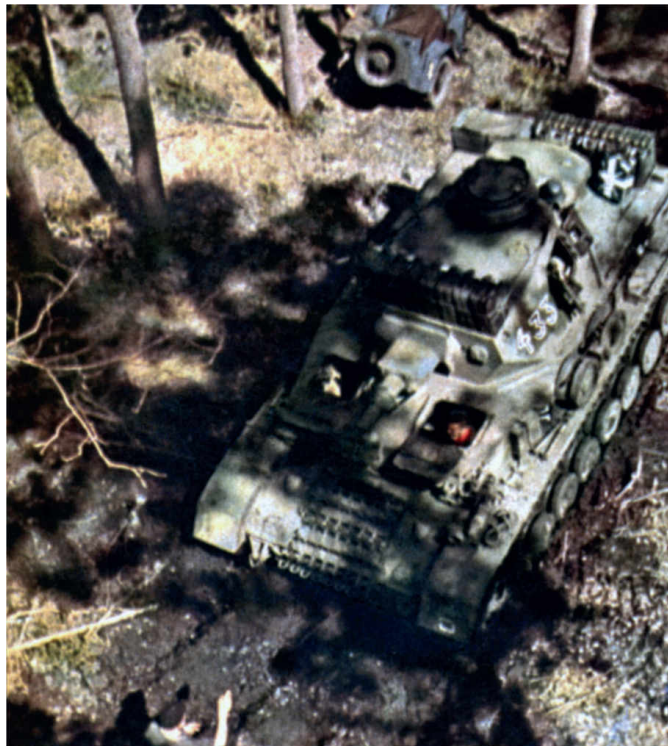
A PzKpfw IV Ausf F sits hidden amongst the trees of the Ardennes in 1940, waiting to drive into France. The Panzer IV was at this stage still armed with the short 7.5cm L/24 howitzer.
(AirSeaLand/Cody)
